# TadiVac2000 Analysis Report For Chip<sup>1</sup> Semiconductor CVD1 / CVD2

Revision: 03

Tadin was asked by Chip Semiconductor Inc. to analyze process data captured using TadiVac2000 Process and Machine Analyzer to identify the sources for process and machine reliability problems of Chip's CVD1 machine. The dominant nature of the problems was said to be unpredicted high particle counts.

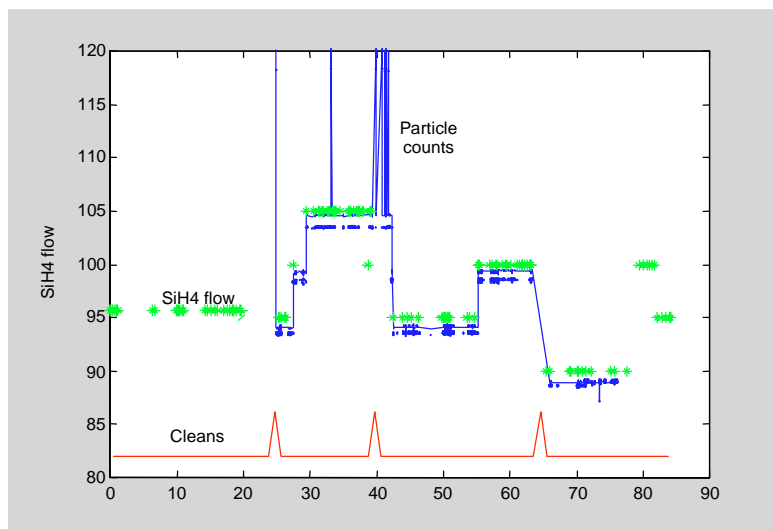
As can be seen on the following graphs, the critical parameter with high correlation to particle-count is the Silane flow-rate. As long as the Silane flow is maintained below 95 SCCM, the particle count is kept under the spec limit. When the flow exceeds 95 SCCM a rapid increase in the particle count is detected. Above 105 SCCM the particle count is occasionally extremely high (More than 10 times the spec limit) and other machine's parameters such as pressure control become highly unstable.

Silane flow correlated with Particle Counts

1. The Silane flow-rate is a critical parameter in regards to particle buildup.
2. The Silane flow is set at a critical level with no process latitude. It is recommended that the Silane and N2O flow-rates will be experimented and set to allow for sufficient process latitude.

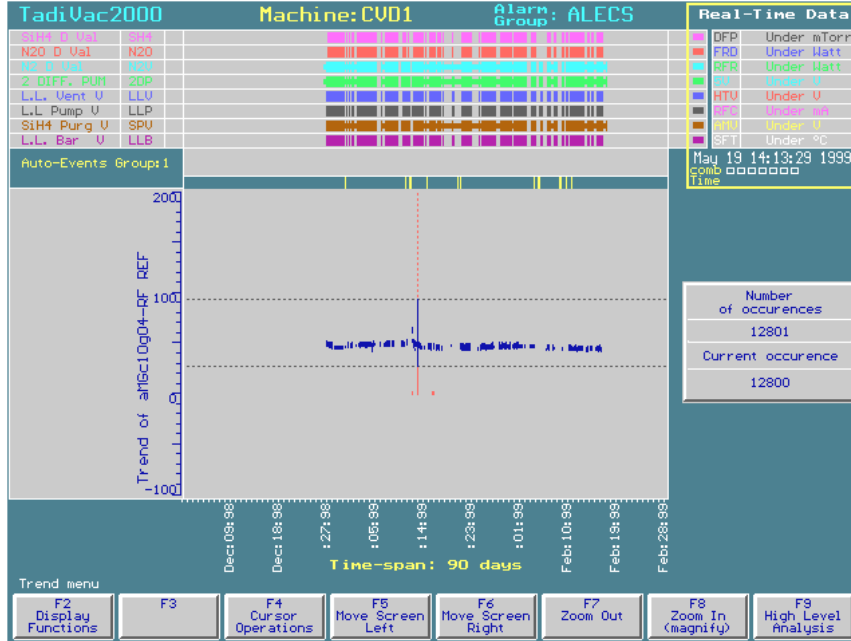
RF Reflected power parameter trend

Note: The RF Reflected has some variation correlated to the RF Forward.

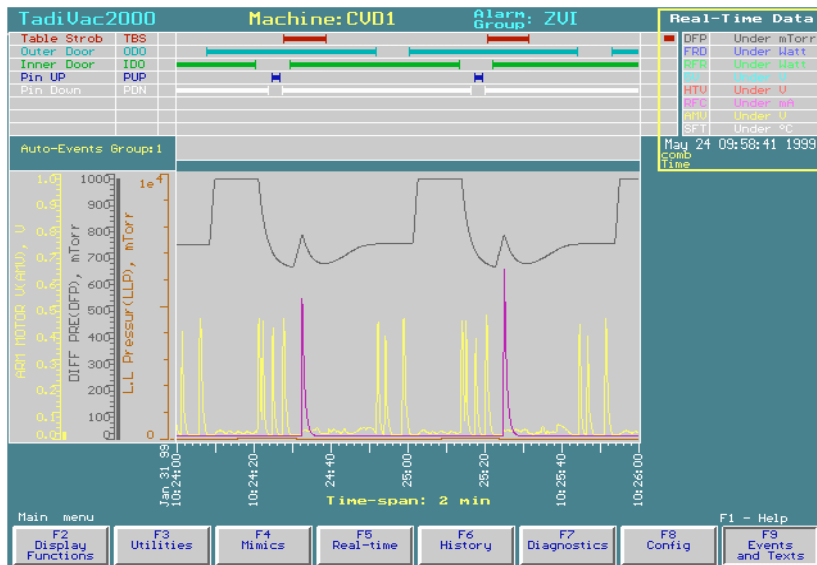
5. A leak or insufficient pumping in CVD1 load-lock can be observed. This results in pressure bursts in the chamber that can cause Oxygen (air) in the chamber and particles. (Page #16)

The data shows clearly that CVD1 differential pressure is too high, causing pressure bursts in the chamber each time the inner door is opened to load a new wafer. There might be a leak or insufficient vacuum pumping at the load lock chamber.

The pressure bursts can cause high Oxygen level in the chamber that can be the reason to many if not most process problems.

CVD1 Load-lock pressure. Note the high level of pressure and the chamber pressure bursts when the inner door opens.

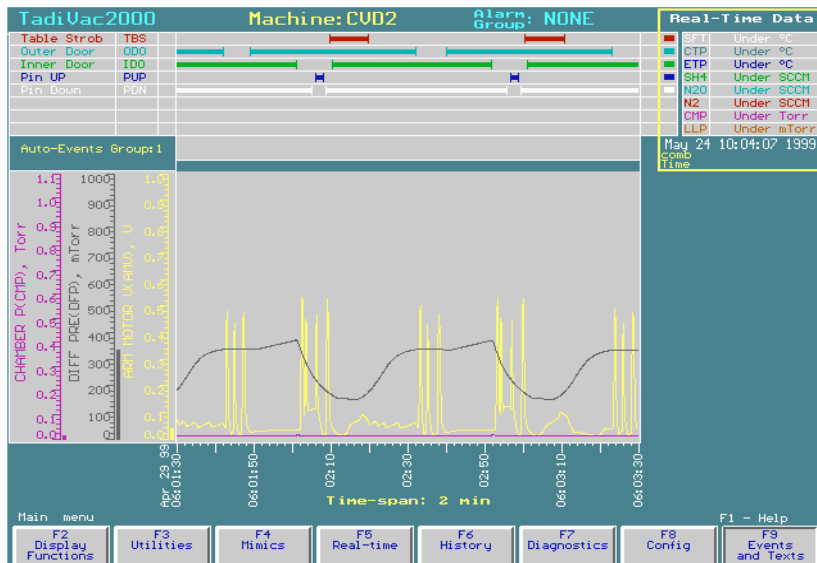
As a reference, CVD2 Load-Lock pumping seems normal. The LL pressure level is sufficiently low, there is no pressure increase in the chamber when the inner door is opened.
